DigitalGlobe's Continuing Coverage of Japan Earthquake/Tsunami, Focus on Fukushima Daiichi Nuclear Facility:

Satellite Constellation Images Plant Seconds Before and Minutes After Explosion at No.3 Reactor Building

FirstWatch
Imagery Report, Japan Earthquake/Tsunami

FW_0011_2011_03_14

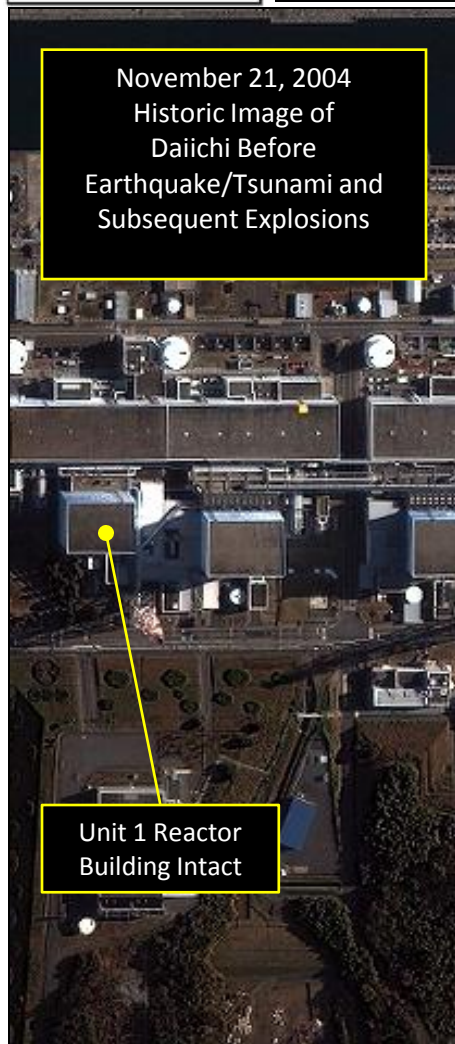
November 21, 2004
Historic Image of
Daiichi Before
Earthquake/Tsunami and
Subsequent Explosions

Unit 1 Reactor
Building Intact

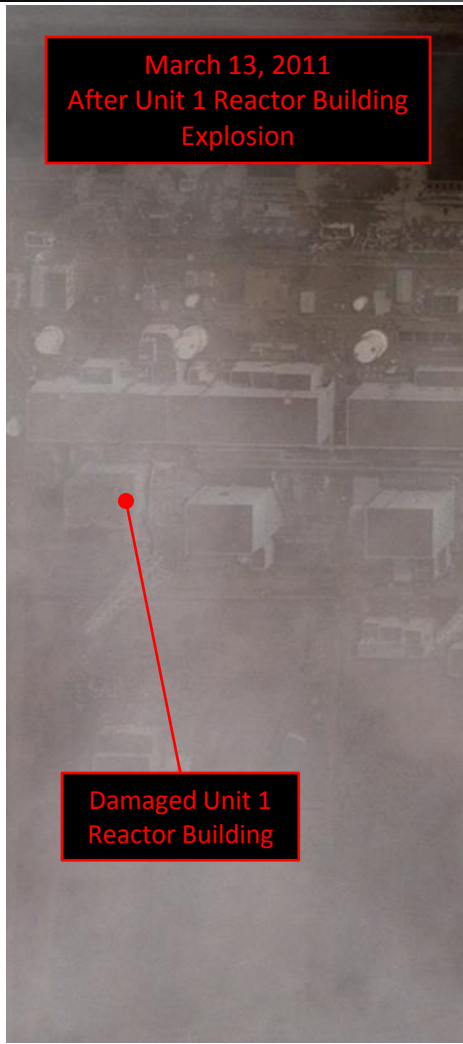
March 13, 2011
After Unit 1 Reactor Building
Explosion

Damaged Unit 1
Reactor Building

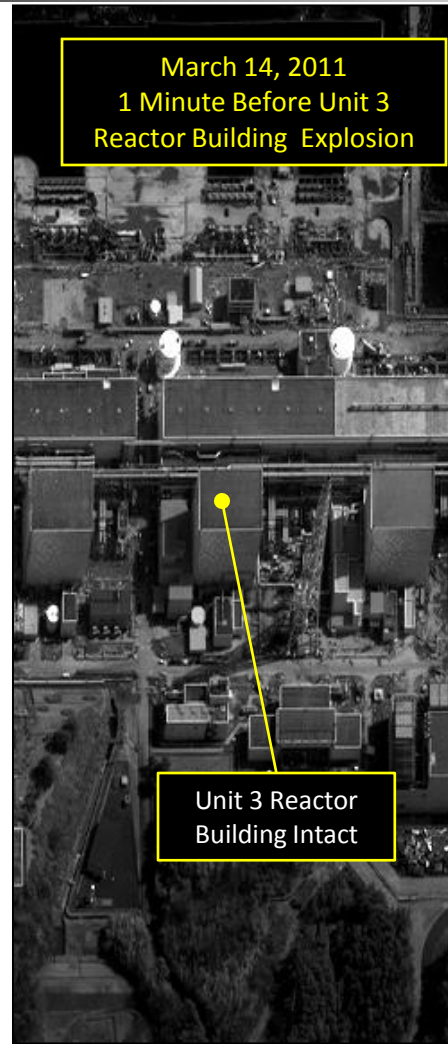
March 14, 2011
1 Minute Before Unit 3
Reactor Building Explosion

Unit 3 Reactor
Building Intact

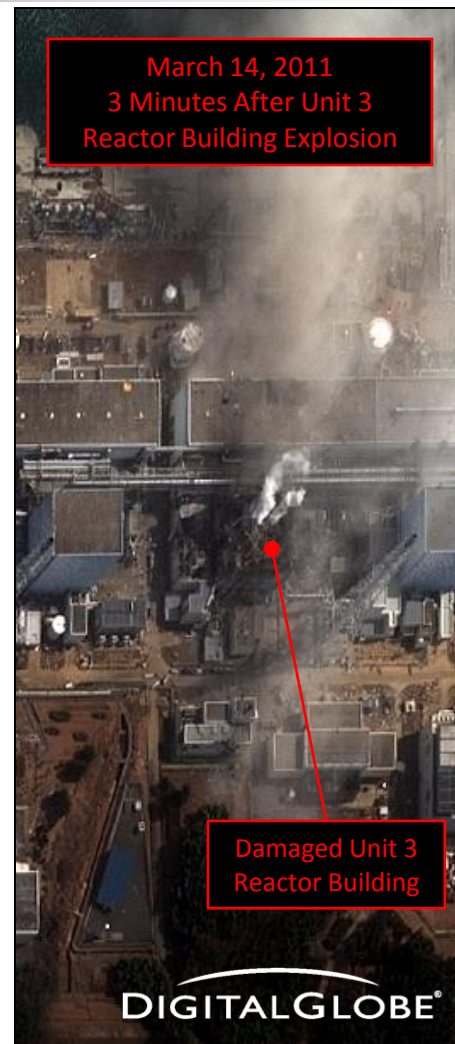
March 14, 2011
3 Minutes After Unit 3
Reactor Building Explosion

Substantial damage could be seen to the reactor building, including the upper structure being largely destroyed with the building's roof and side panels blown off. In addition, an extensive smoke and dust plume could be seen drifting east approximately 2 kilometers from the damaged reactor building.

Damaged Unit 3
Reactor Building

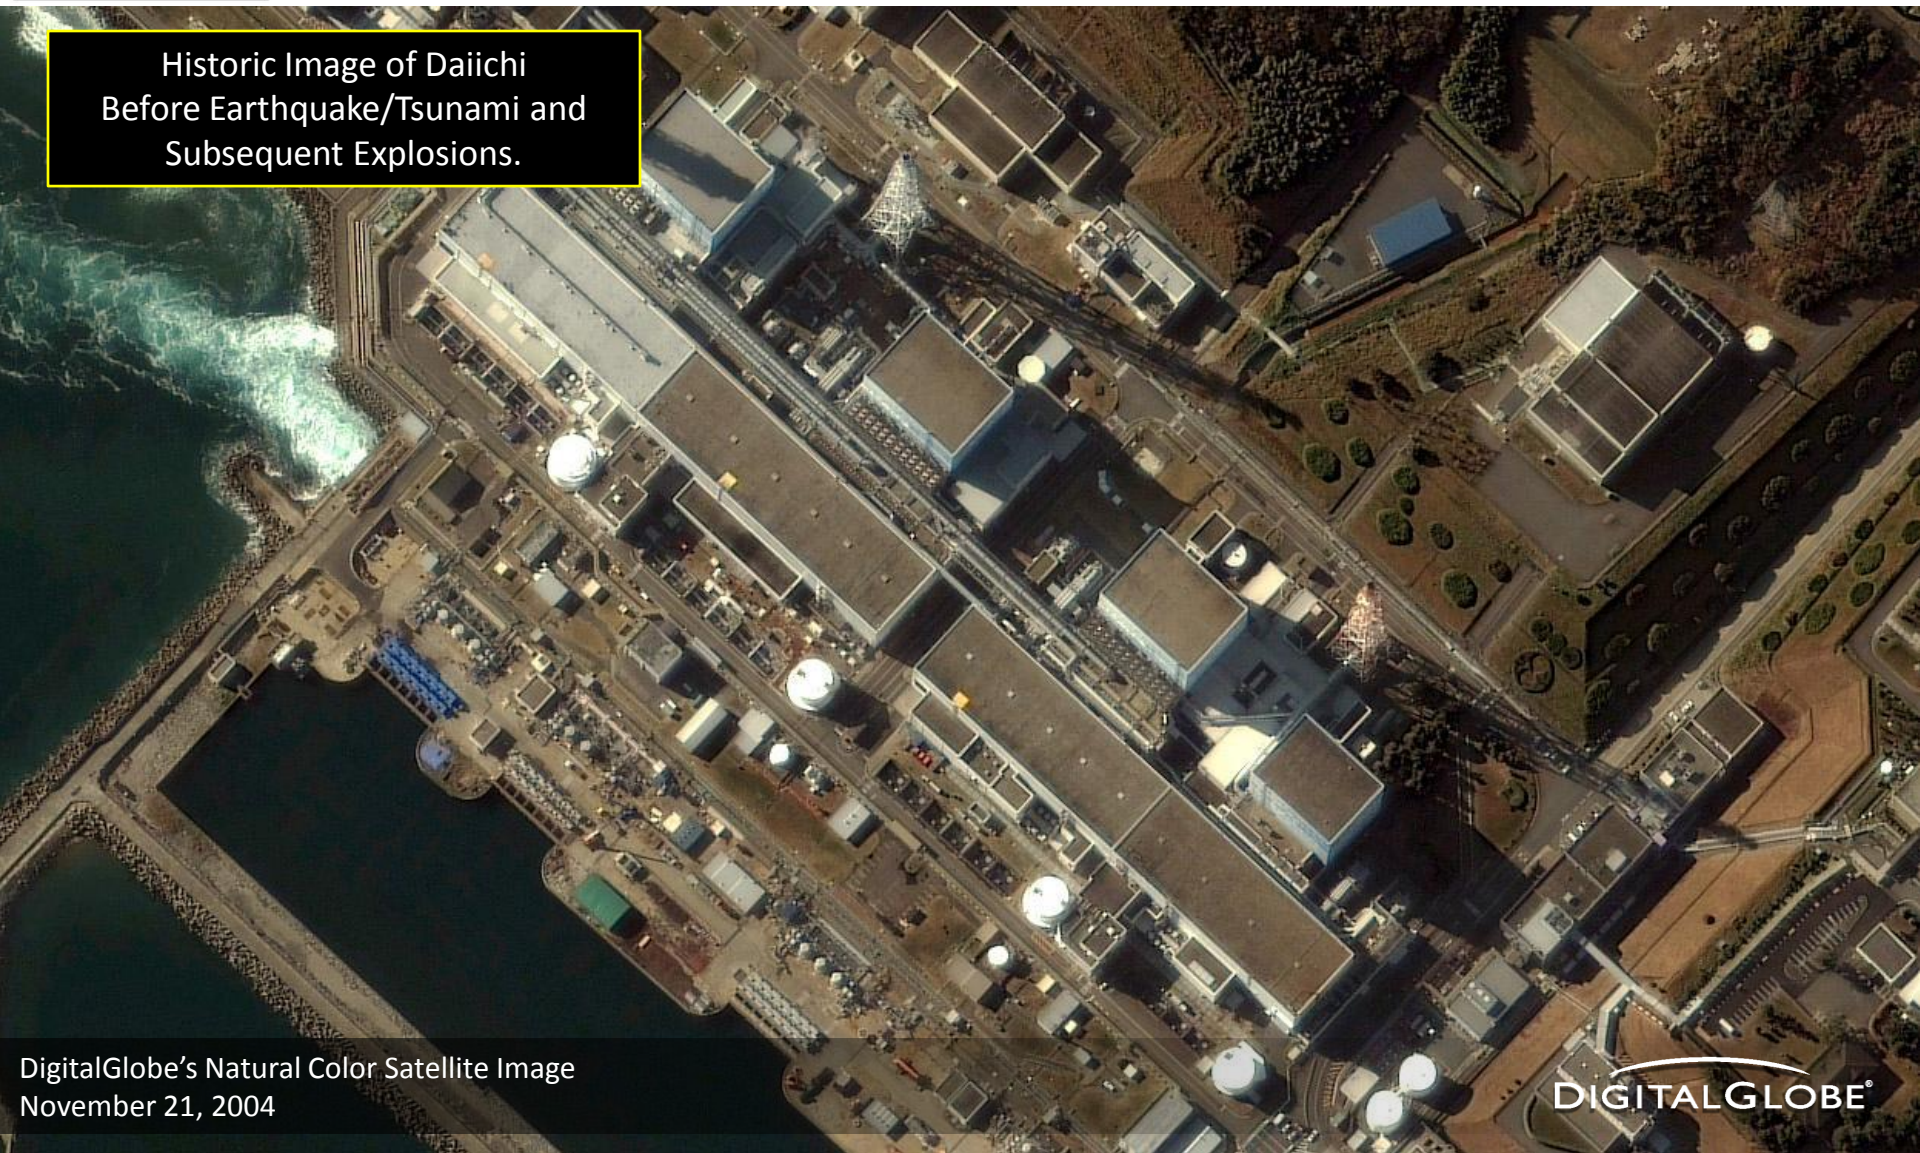
Historic Image of Daiichi
Before Earthquake/Tsunami and
Subsequent Explosions.

DigitalGlobe's Natural Color Satellite Image
November 21, 2004

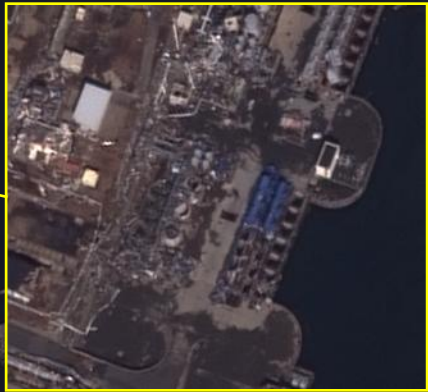
Before Unit 1
Reactor Building
Explosion

Unit 1 Reactor
Building Intact

Significant Damage to Surface
Structure/Water Intake Screens

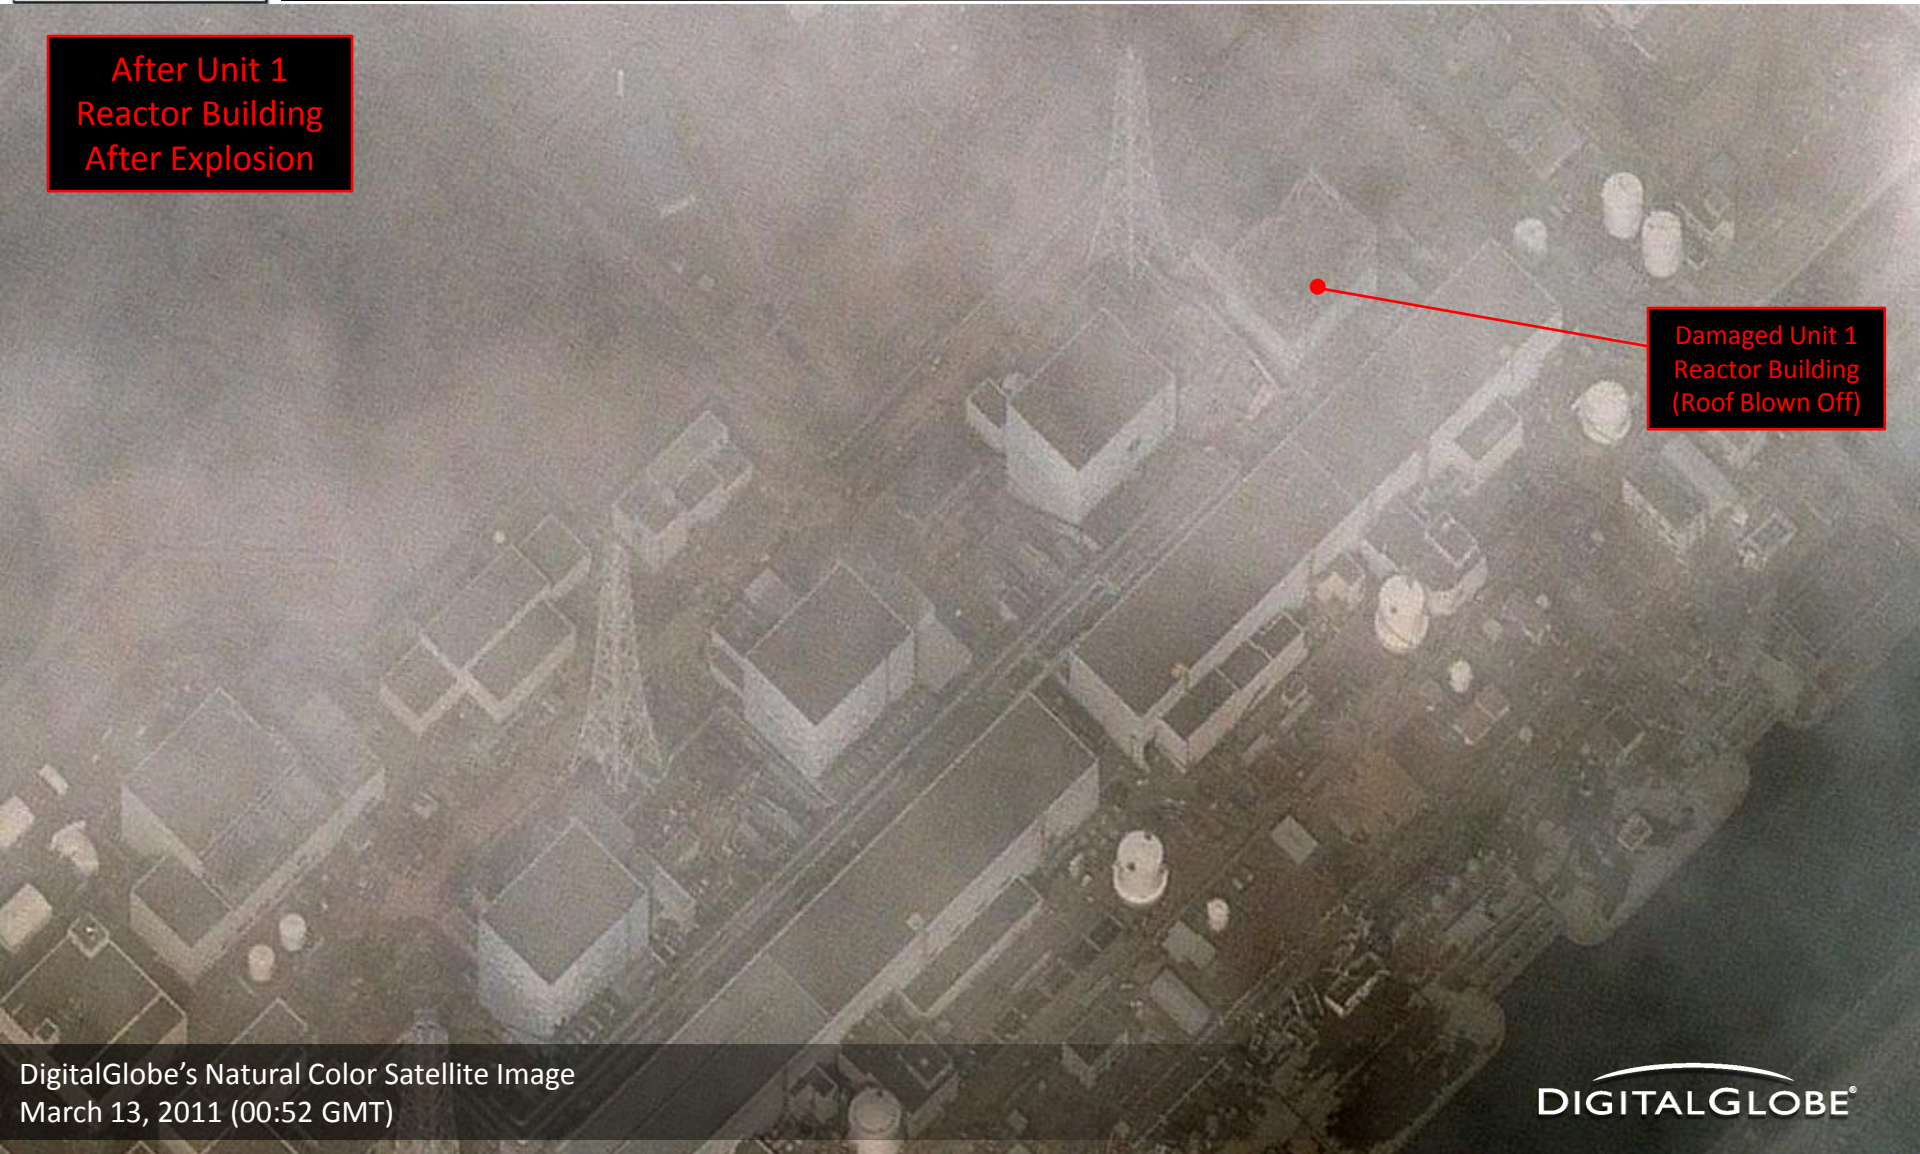
After Unit 1
Reactor Building
After Explosion

Damaged Unit 1
Reactor Building
(Roof Blown Off)
